**ÖZCİHAN MAKİNA**  
Özcihan Makina San. ve Tic. Ltd. Şti  
www.ozcihan.com.tr

## ARA ŞANZİMAN / SPLIT SHAFT (PTO)

**CTM 336 2000**

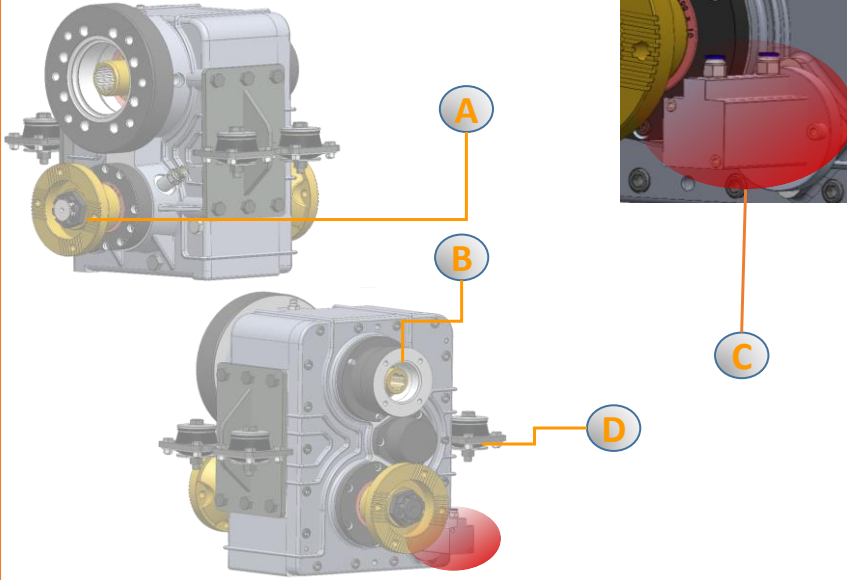
### GENEL BİLGİLER / GENERAL INFORMATION

#### OPSİYONLAR / OPTIONS

- A** GİRİŞ / INPUT
- B** ÇIKIŞ / OUTPUT
- C** HAVALI KONTROL / AIR CONTROL
- D** YAN BAĞLANTI KİTİ / SIDE CONNECTION

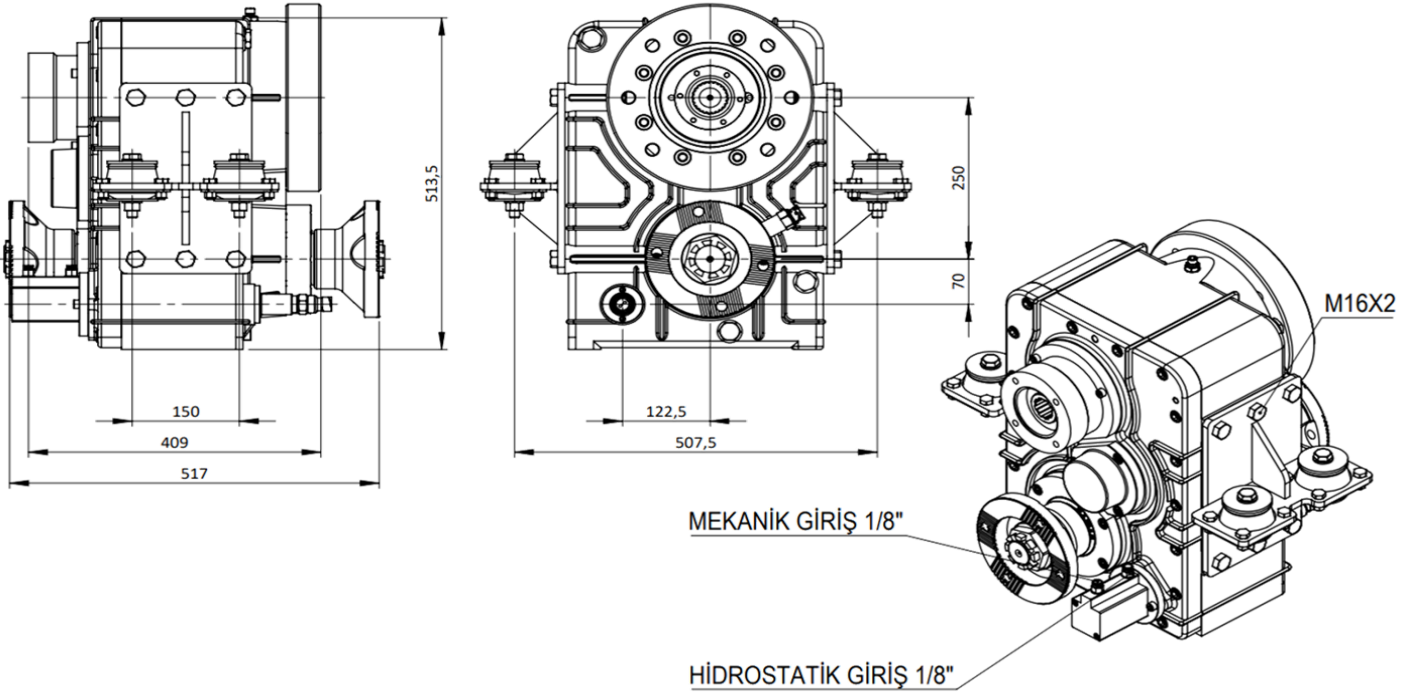
**TEKNİK ÇİZİM / TECHNICAL DRAWING**

**A** ANA SHAFT / MAIN SHAFT

TORK / TORQUE: 12.000 Nm

**B** ÇIKIŞ GÜCÜ / OUTPUT FORCE ( 1000 dev/dk) ORAN/RATIO : 1,12

TORK / TORQUE: 75 Kgm ( 735Nm) - GÜÇ / POWER : 78 KW

AZAMİ HIZ/ MAX. SPEED

2800 - 3300 RPM

AĞIRLIK / WEIGHT

170 Kg

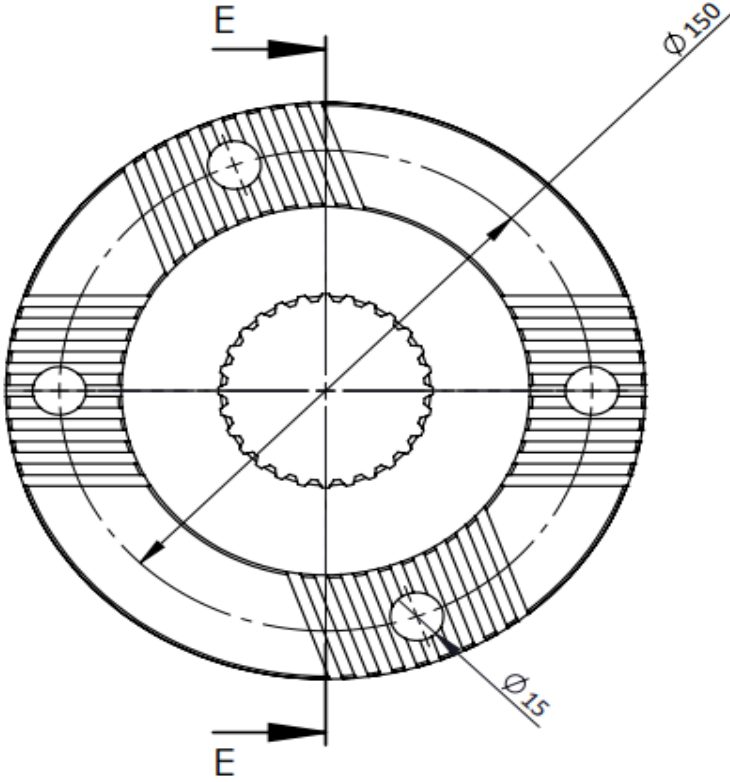
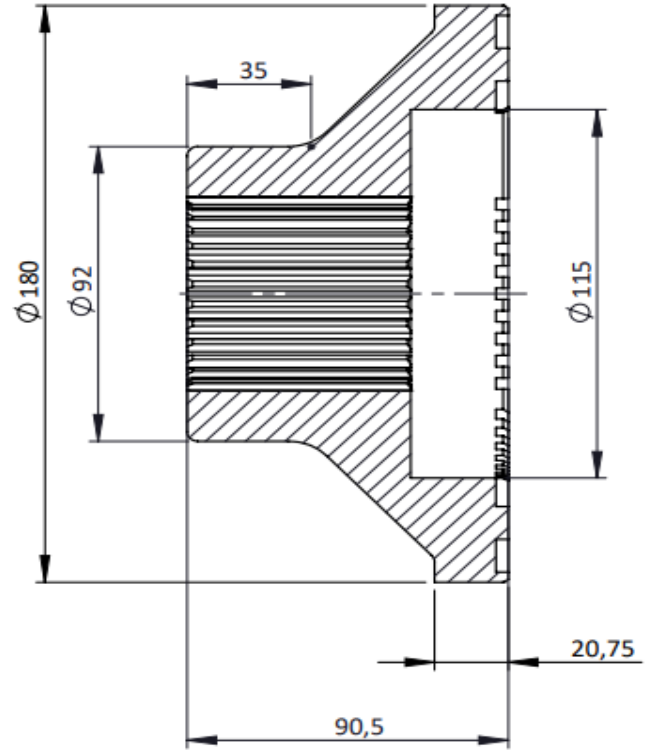
**ANA FLANŞLAR / MAIN TRANSMISSIONS**

Ø180 **1.12.336** Z:28 (ISO 8667)
